U.S. ARMY RESEARCH, DEVELOPMENT AND ENGINEERING COMMAND

ECBC-TR-522

VALIDATION OF FMTV MODULAR VHP/mVHP SYSTEM AND FUMIGATION DECONTAMINATION PROCESS IN A C-141B STARLIFTER AIRCRAFT

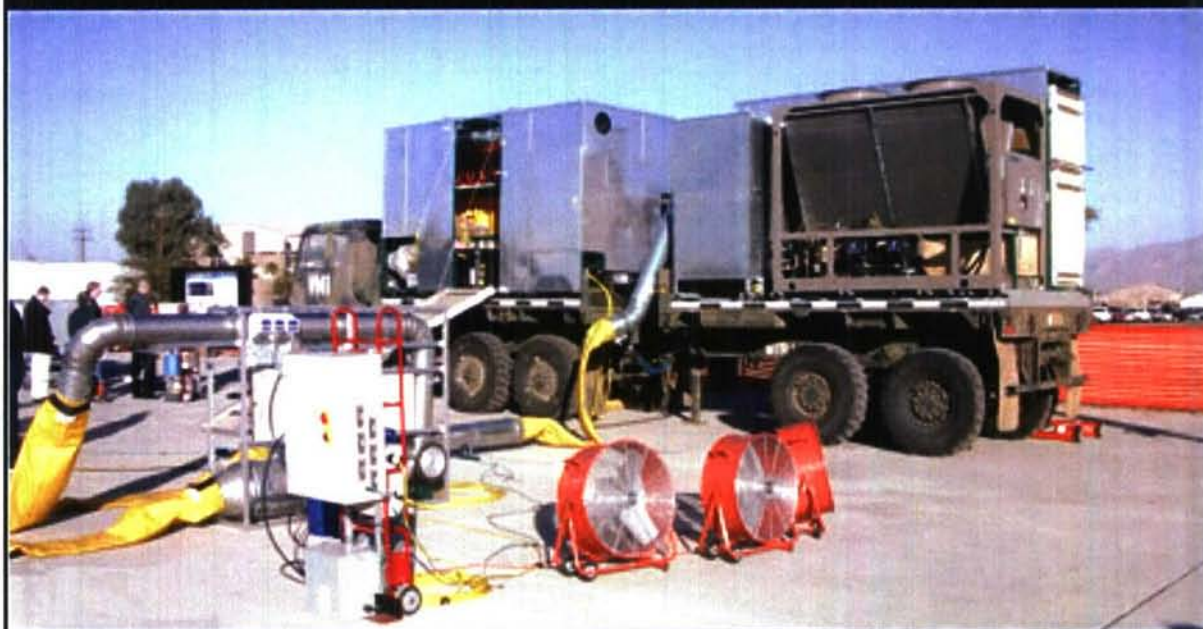
Figure 2.1: FMTV System

Steris provided the FMTV for testing at Davis-Monthan AFB. Permanent components of the FMTV include an electrical generator, a power distribution panel, an exhaust system, a heat exchanger, an air compressor and a central control panel (Figure 2.1). Permanent components of the FMTV trailer include a dehumidifier/condenser, and an air handling unit. The trailer can also carry ten modular vaporizer units, each rated to 100 cfm, one large vaporizer unit, rated to 1000 cfm, 38 distribution fans, and sufficient ducting. As a complete package, the FMTV system can provide up to 100,000 ft³ of decontamination capacity.

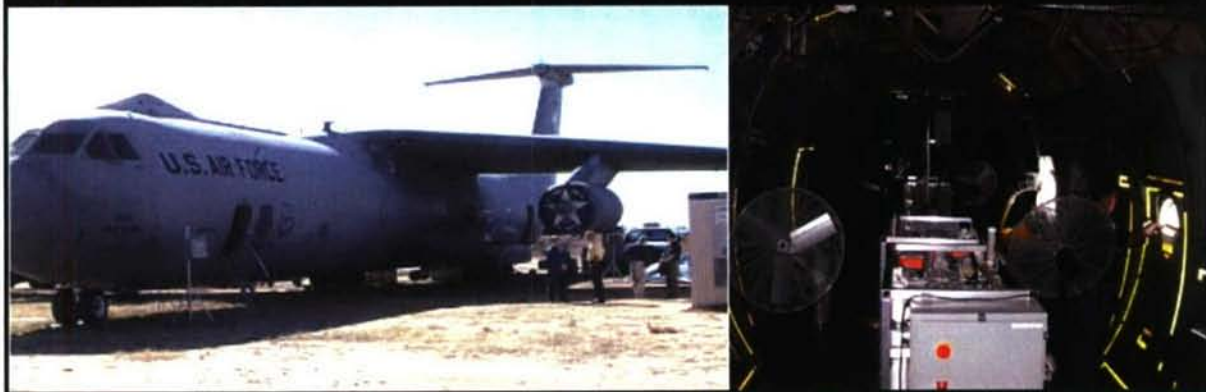
Figure 2.2: C141 Aircraft

The C-141B Starlifter, designed for long-range troop and cargo airlift, has a cargo length of 168 ft 4 in, a height of 39 ft 3 in, and a wingspan of 160 ft. The cargo load capacity was rated at 6,370 ft³, but for decontamination purposes, the total cargo area volume was taken as approximately 13,000 ft³ of air (Figure 2.2). The cargo area was cleared of excess debris for equipment placement. The clam shell-rear cargo hatch and the port side rear access hatch were sealed on the exterior with tape. The Medium Tactical Vehicle (MTV) and modular mVHP system were positioned just behind the port wing.
